“Full” Reserve Study

Yosemite Village Denver, CO

Report #: 29235-0
For Period Beginning: January 1, 2016
Expires: December 31, 2016

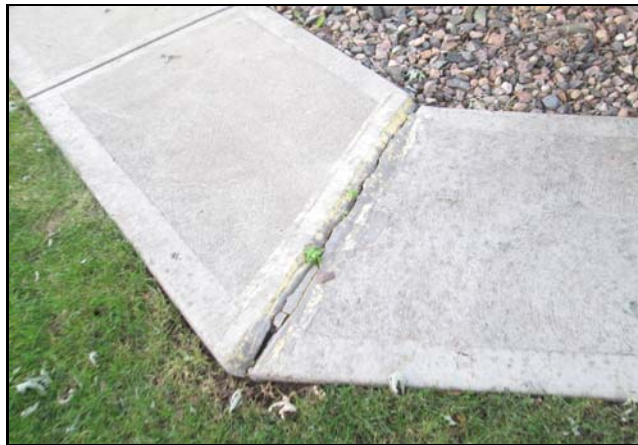
Comp # : 2107 Concrete Sidewalks - Repair

Remaining Life:

4 years

Best Case: \$9,000

Worst Case: \$11,000

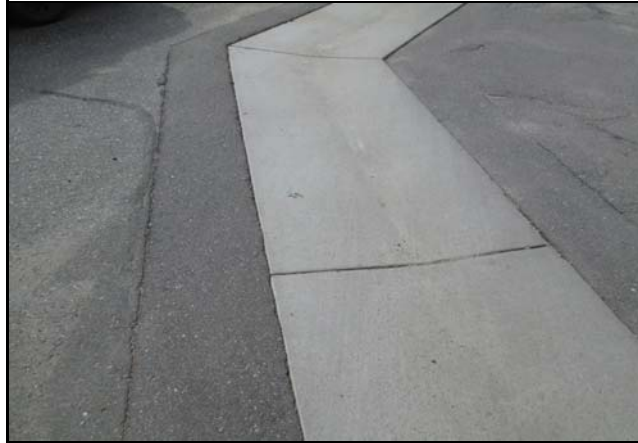
Useful Life:
15 years

Remaining Life:
8 years

Best Case: \$6,000

Worst Case: \$8,000

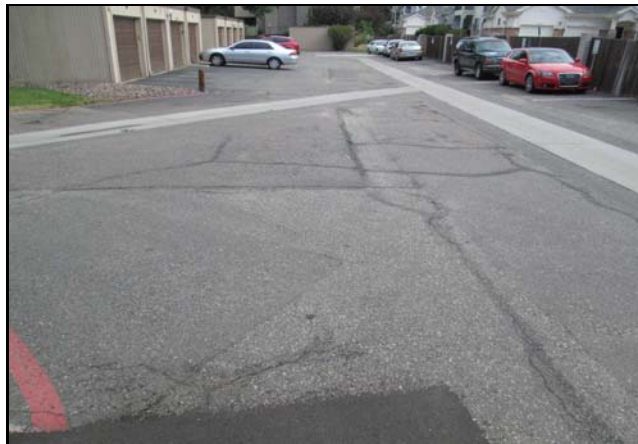
Useful Life:
4 years

Remaining Life:
0 years

Best Case: \$16,000

Worst Case: \$18,000

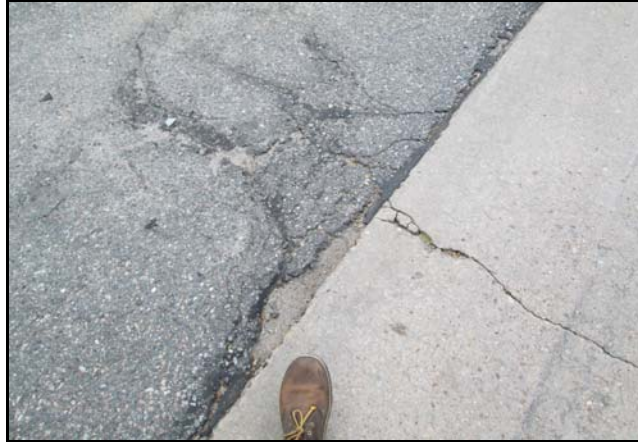
Useful Life:
25 years

Remaining Life:
8 years

Best Case: \$162,000
Lower allowance

Worst Case: \$270,000
Higher allowance

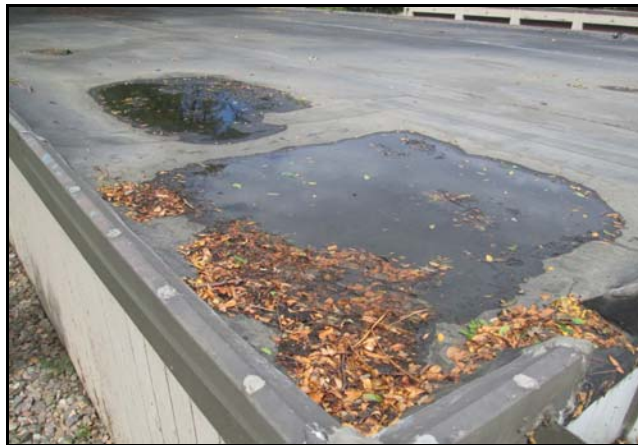
Useful Life:
20 years

Remaining Life:
0 years

Best Case: \$105,000
Lower allowance

Worst Case: \$115,000
Higher allowance

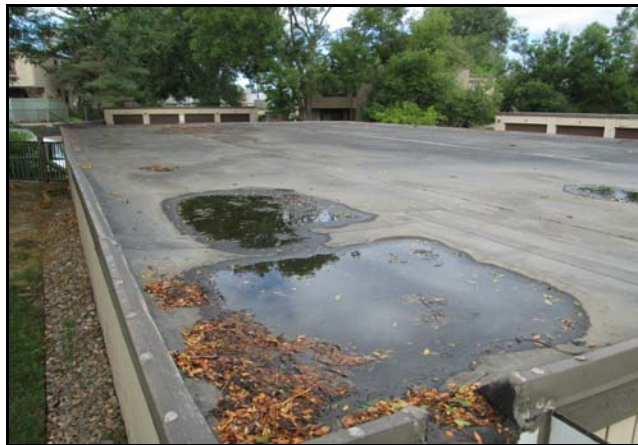
Useful Life:
20 years

Remaining Life:
1 years

Best Case: \$105,000
Lower allowance

Worst Case: \$115,000
Higher allowance

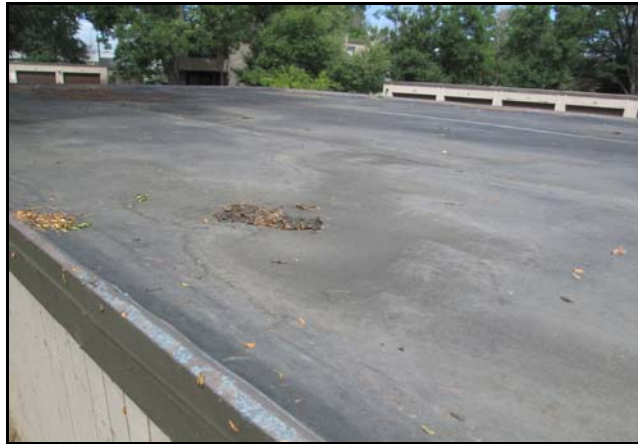
Useful Life:
20 years

Remaining Life:
2 years

Best Case: \$90,000
Lower allowance

Worst Case: \$110,000
Higher allowance

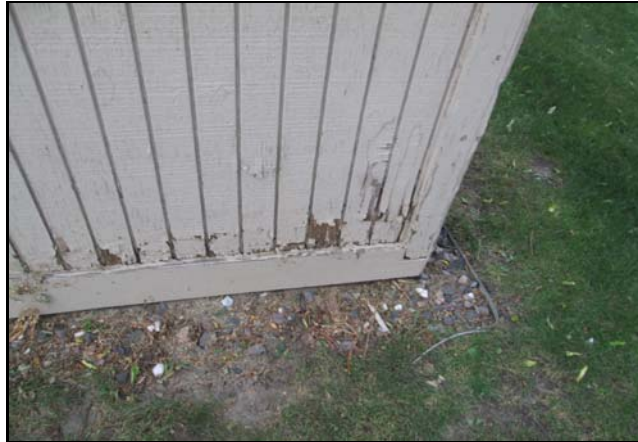
Useful Life:
8 years

Remaining Life:
3 years

Best Case: \$10,000
Lower allowance

Worst Case: \$14,000
Higher allowance

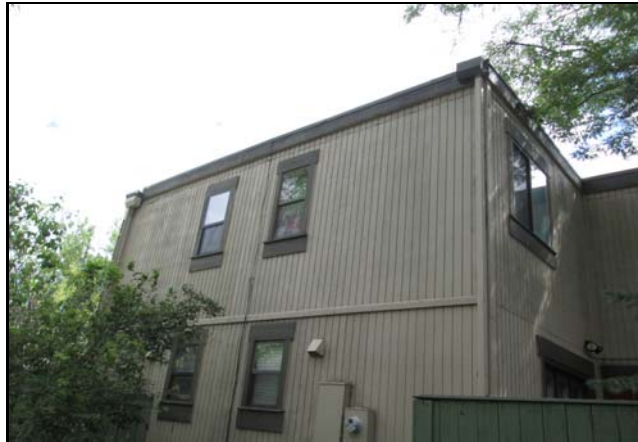
Useful Life:
8 years

Remaining Life:
0 years

Best Case: \$125,000

Worst Case: \$150,000

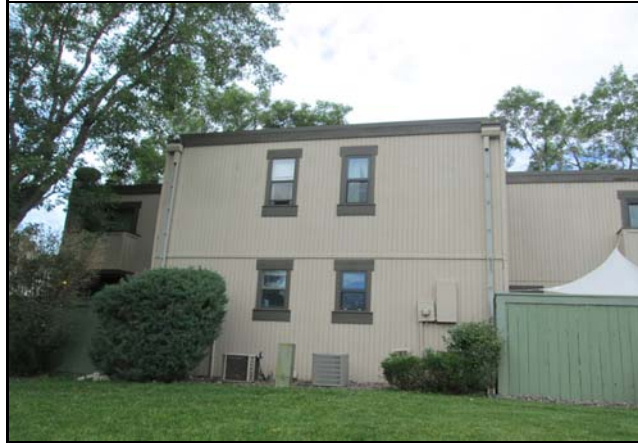
Useful Life:
8 years

Remaining Life:
0 years

Best Case: \$75,000

Worst Case: \$85,000
